DEPARTMENT OF TRANSPORTATION**DIVISION OF ENGINEERING SERVICES**

Quality Assurance and Source Inspection

Contract #: 04-0120F4Cty: SF/ALA Rte: 80 PM: 13.2/13.9File #: 74.28**WELDING INSPECTION REPORT****Resident Engineer:** Siegenthaler, Peter**Address:** 333 Burma Road**City:** Oakland, CA 94607**Report No:** WIR-020232**Date Inspected:** 26-Jan-2011**Project Name:** SAS Superstructure**OSM Arrival Time:** 800**Prime Contractor:** American Bridge/Fluor Enterprises, a JV**OSM Departure Time:** 1730**Contractor:** Goodwin Steel, UK**Location:** Trentham, UK

| Bridge No: | 34-0006 | Component: | Cable Band | | | | |

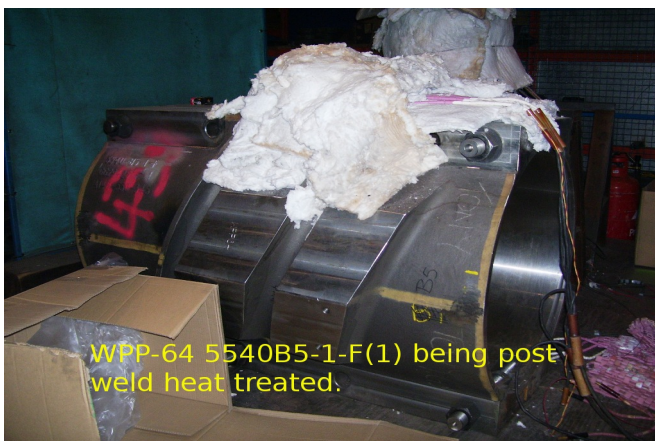
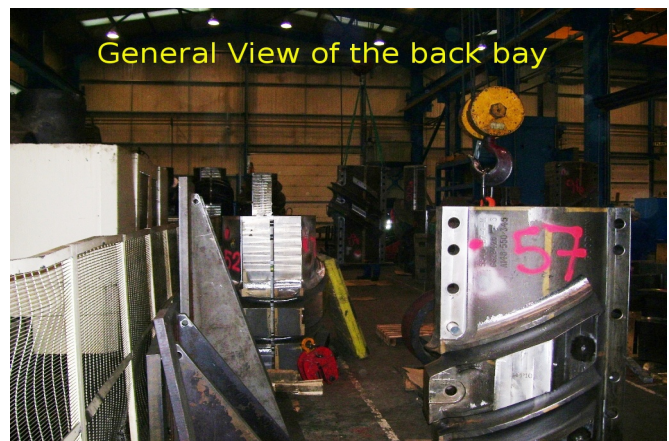
The QA inspector periodically observed that Goodwin International personnel perform finish grinding of an assembled B9 Type 1 cable band for east panel point 28 (EPP-28) consisting of castings 5540-B9-1-M-8, and 5540-B9-1-F-8. The rope grooves are being dressed, an assembled B9 Type 1 cable band consisting of castings 5540-B9-1-M-5, and 5540-B9-1-F-6, the rope grooves were observed being dressed and an assembled B9 Type 1 cable band for west panel point 28 (WPP-28) consisting of castings 5540-B9-1-M-7, and 5540-B9-1-F-5, the hand rope stanchion pads were being dressed. In addition, all sharp edges from the machining operations and suspender groove transitions are being ground to required finish by Goodwin International personnel.
